Bearing Steel Microstructures after Aircraft Gas Turbine Engine Service

J. R. Nygaard, M. Rawson, P. Danson, H. K. D. H. Bhadeshia

Materials Science and Technology 30 (2014) 1911-1918

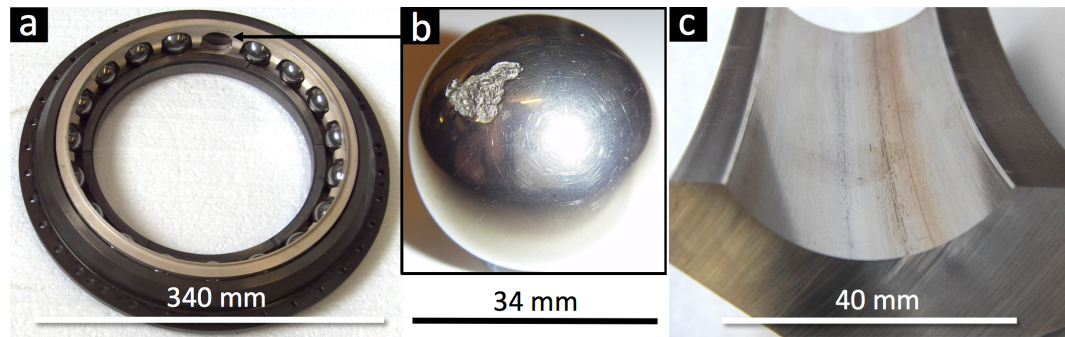
Figure 1: a). Rolls-Royce Trent engine location bearing with inner raceway removed to reveal the rolling elements held within the cage. b). M50 bearing ball removed after 30,000h service displaying a fatigue spall. c) Cross-sectioned M50NiL outer raceway after 30,000h service displaying tracks of discolouration at positions which indicate thrust loading.

In the present work, a single ball failure resulted in the discontinuation of the 30,000 h bearing following spalling damage [Fig 1b]. Fractography revealed the fatigue spall had occurred at a location away from the polar regions, so carbide segregation was not thought responsible. Instead, a crack found running through the spall was forcibly opened to reveal a subsurface fatigue zone approximately 1 mm beneath the contact surface [Fig 2c]. The fatigue striations in this zone suggest a subsurface crack initiated fatigue failure, but the exact source could not be identified conclusively.

Visual examination of the used M50NiL raceways shows tracks of discolouration which indicate the rolling history of the balls during service. Optical microscopy within these tracks reveals scoring damage and curved indentations caused by ball spinning under thrust loading [Fig 3a]. It is thought that the hard primary carbide asperities on the surfaces of the balls are responsible for such markings. These curved scratches imply a certain amount of sliding takes place within the contact ellipse, and it is this sliding between components that produces a surface shear significant to RCF. Gloeckner and Ebert [35] witnessed similar features under high-speed bearing operation, concluding that sliding shear leads to heat generation, plastic flow and micro-spalling within the contact zone, and hence is a key contributor to surface initiated failures in aircraft gas-turbine engine bearings.

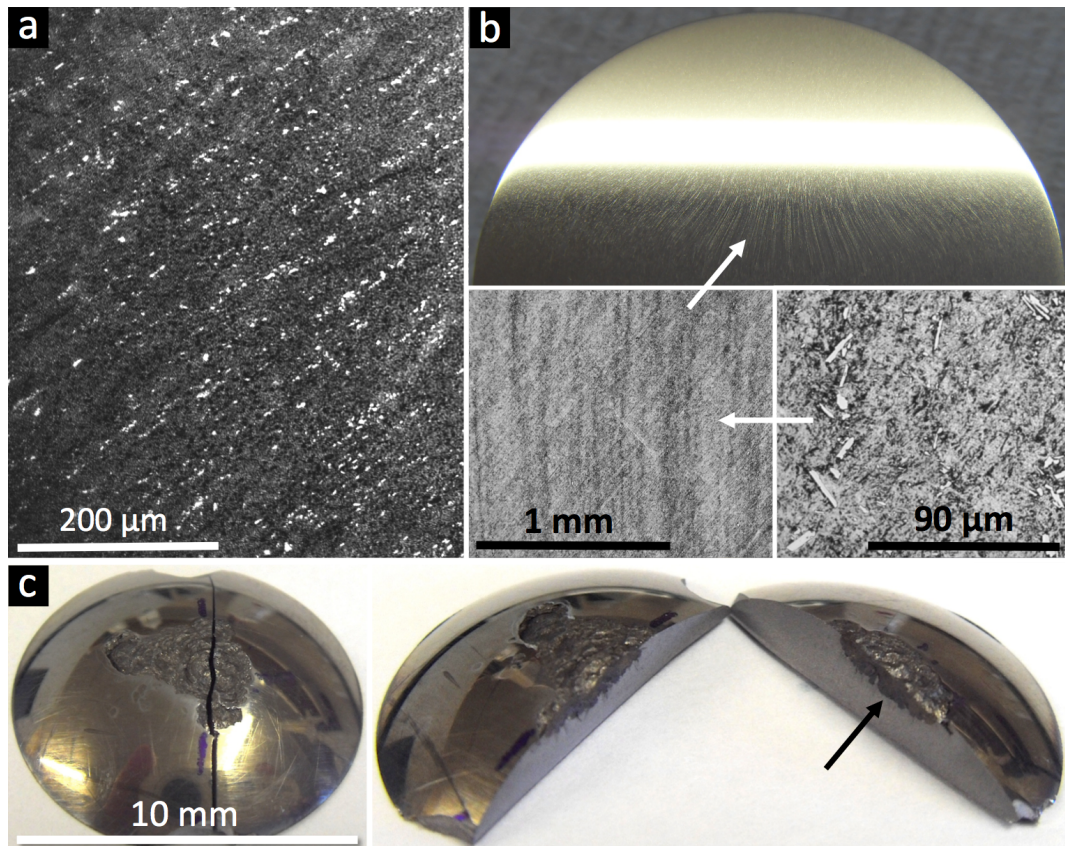
Figure 2: a). M50 bearing ball surface etched to reveal directional primary carbides with bright contrast. b). Cross-sectioned M50 ball interior showing grain flow lines of segregated carbides under optical microscopy. c). Fatigue spall on bearing ball after 30,000 h displays a subsurface crack forcibly opened to reveal a fatigue zone approximately 1 mm in depth (arrowed).

M50 bearing balls contain primary carbide stringers at their contact surfaces [Fig 2a], tracing lines of longitude about the spherical components, leading towards two poles at opposite ends of the ball. The stringers permeate throughout the ball interior [Fig 2b], akin to the skins of an onion, and have been cited as the cause for dynamic imbalance in M50 balls [41]. The origin of the stringers is associated with segregation during solidification, which is spread along the length of the bars used as the raw material for the production of balls. This anisotropy in through-hardened balls is referred to as “grain flow” and historically has been blamed for preferential fatigue failures occurring at the polar regions [42, 43, 44].

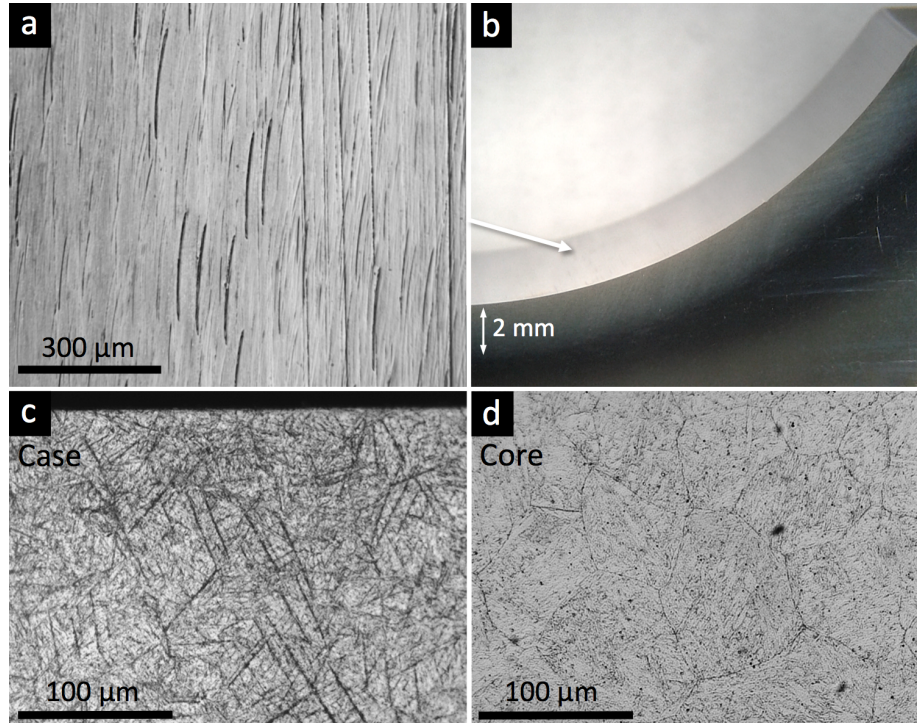
Figure 3: a). Curved scores on the M50NiL raceway after 120 h service caused by ball spinning, (the rolling direction is north to south). b). A cross-section of this M50NiL raceway shows 2 mm deep carburised case after colloidal silica polish. c). Optical micrograph of this high carbon case after etching to reveal plate martensite features. d) The M50NiL core at depths greater than 3 mm shows an etched microstructure of lath martensite with visible prior austenite grains.

Optical microscopy beneath the raceway surfaces reveals the M50NiL material remains in good condition for all the used bearings examined. The carburised case is densely populated with fine, well-dispersed carbides to a depth of approximately 2 mm [Fig 3b]. Upon etching the high-carbon martensite plates of the case visibly darken [Fig 3c], but much larger features with more irregular morphologies were also encountered here, as shown later in Fig 4. All three raceways exhibited these atypical features within the first 500 μm of their case depth, including the unused bearing. The low carbon microstructure of the M50NiL core resists etching although the prior austenite grains are clearly visible [Fig 3d], unlike in the case. At depths greater than 3 μm beneath the carburised surface the average grain size as characterised using the mean lineal intercept method is $50\ \mu\text{m} \pm 10\ \mu\text{m}$ (ASTM 6), with a standard deviation of 20 μm between the three raceways.

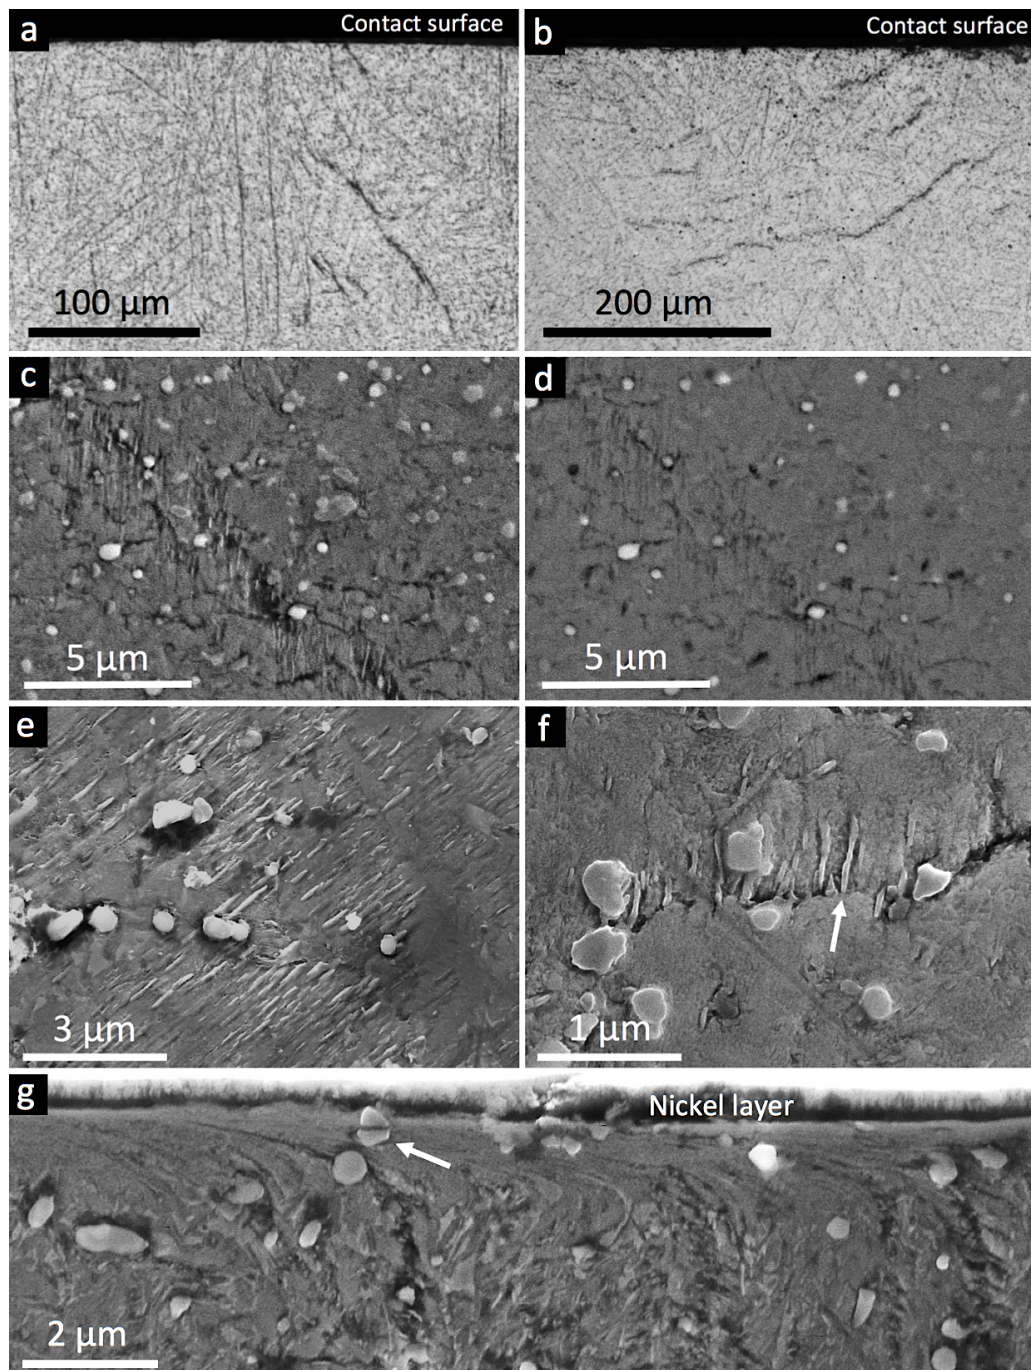
Scanning electron microscopy revealed the M50NiL etching features are well-orientated parallel bands [Fig 4c]. Backscattered electron (BSE) imaging did not lead to enhanced contrast in the bands, indicating they do not differ in composition from their surroundings, [Fig 4d]. The spherical carbides in the case-carburised zone average less than 1 μm in diameter with greyscale contrast indicating species with differing average atomic number. EDX analysis confirmed V_4C_3 and Mo_2C , similar to the M50 alloy, as is consistent with [49]. The parallel bands in the M50NiL carburised case were imaged at a higher resolution using FIB-SEM [Fig 4e] and later sectioned. Many instances were identified where these structures decorated prior austenite grain boundaries [Fig 4f]. There was a shallow zone of deformation near the contact surface that was not visible optically. Used raceways sectioned in the tangential direction of rolling show evidence of significant plastic flow just 1-2 μm beneath the point of contact [Fig 4g]. This is powerful evidence of directional deformation under surface shear between components experiencing sliding contact, and within this zone a cracked carbide is identified.

Figure 4: a). Large etching features within the carburised case of M50NiL raceways. b) The features follow irregular paths and intersect the contact surface. c). Secondary electron image of etching feature shows parallel band structures within. d). Backscatter image of same region. The bands show no compositional difference to the matrix, unlike the bright Mo_2C carbides. e). FIB-SEM image of the M50NiL bands shows their plate-like morphology. f). Plates initiate along an M50NiL prior austenite grain boundary interface (arrowed). g). Secondary electron image of the 120 h raceway shows severe plastic flow beneath the contact surface in the direction of rolling (right to left). A protective layer of nickel is deposited to protect these shallow surface features, where a cracked carbide is also located (arrowed).

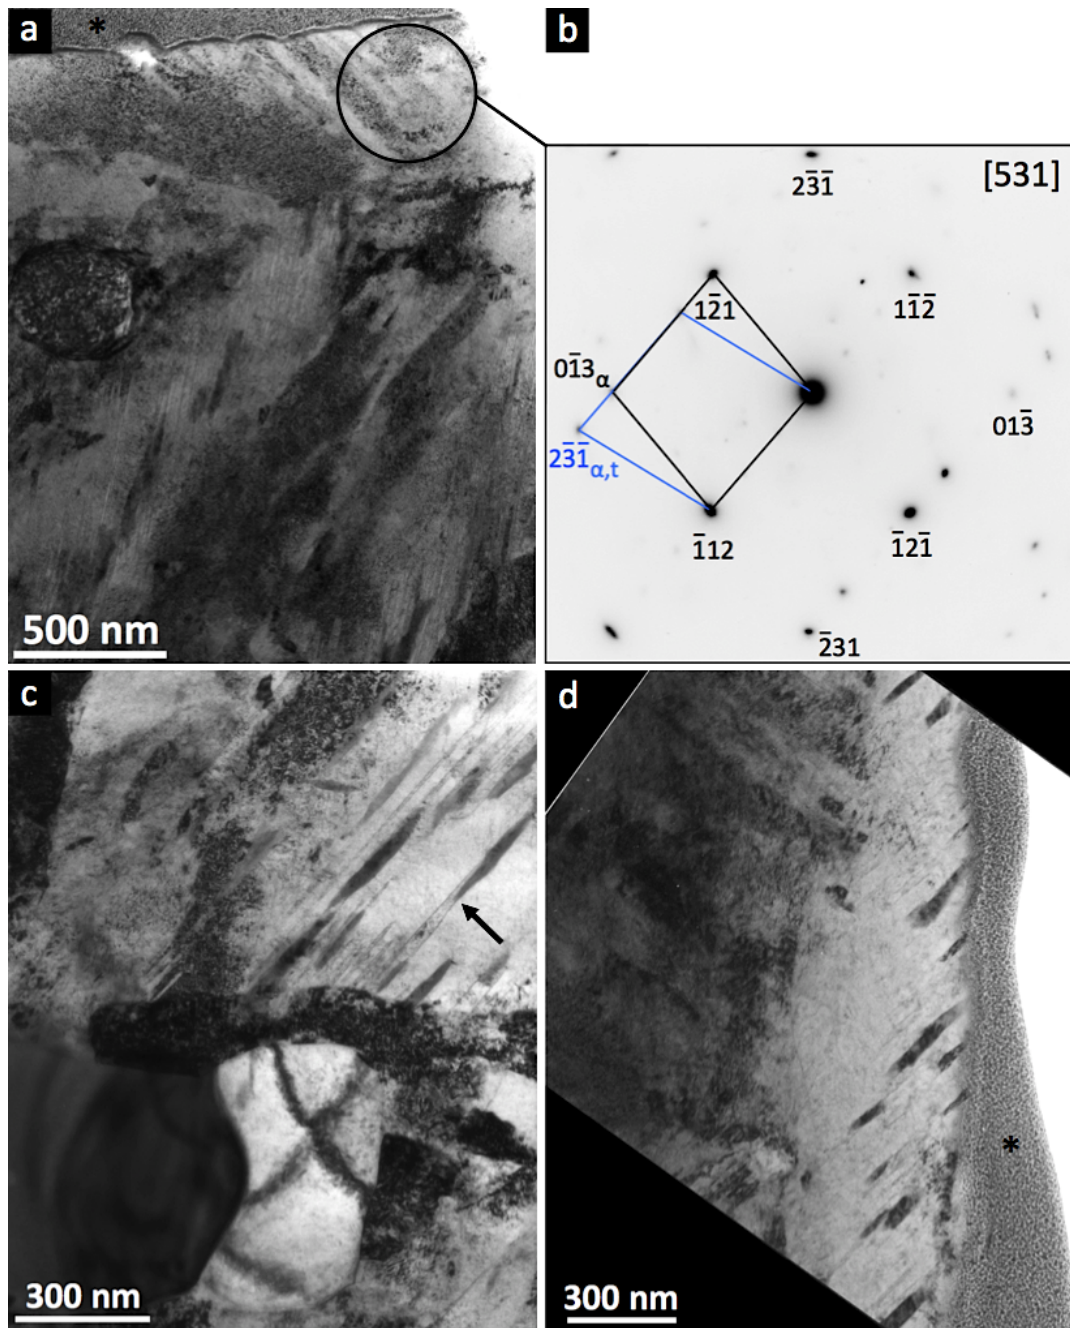
Fig 5 shows TEM micrographs of the deformed band structures and the associated diffraction pattern indicating twinned martensite. Away from these regions, the general M50NiL microstructure is that of heavily dislocated martensite plates with spherical carbides and fine

Figure 5: a). Bright field TEM micrograph of bands in the M50NiL case-carburised zone after 30,000 h service. A platinum layer* protects them during ion milling. b). Diffraction pattern of the bands showing a twinned structure. c). M50NiL case after 30,000 h service showing deformation twins with emissary dislocations at their apex. d). M50NiL case after 0 h service. This foil was taken from bands that decorated a prior austenite grain boundary [Fig 5f]. The lenticular morphology is consistent with deformation twinning.

twins. TEM foils reveal that the plate-like morphologies of the bands are consistent with deformation twins in martensite [Fig 5c], substantiated by observations of emissary dislocations produced at their apex [50]. The presence of these twins along the prior austenite grain boundary interface, as previously shown in Fig 4f, is evidence of their strain-induced nucleation. Deformation twinning is observed in the case-carburised zone of all three M50NiL raceways, indicating that service stresses are not responsible. Plastic deformation during processing and finishing of the component surfaces may be the cause. The significance of these localised, plastically-deformed regions is not clear but mechanical twinning might compromise integrity if it occurs with sufficient intensity. Such inhomogeneities in the raceway microstructure may represent defects prior to service, particularly where they intersect the contact surface [Fig 5b]. Future work should aim to quantify and ascertain whether the features become more numerous during service.

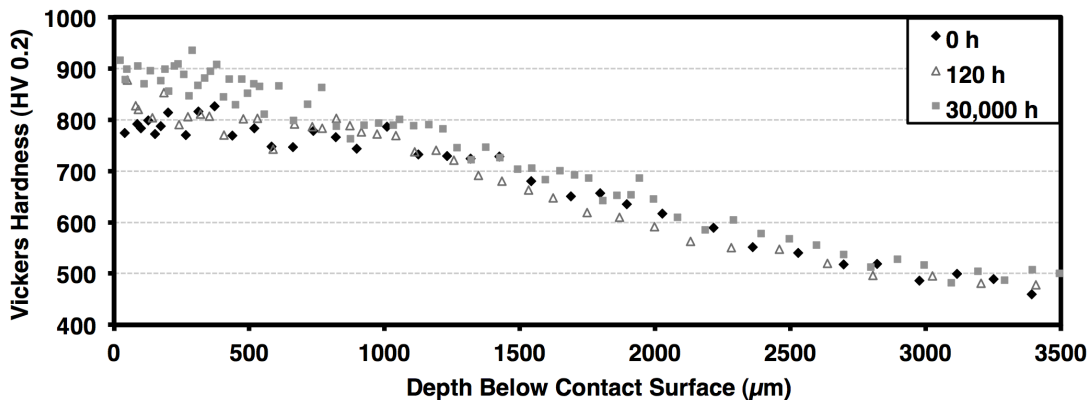
Microhardness data on M50NiL raceways are shown in Fig 6. The 0 h raceway material shows a hardness gradient characteristic of the carburised case with values exceeding 800 HV0.2 (64 HRC) at the surface, falling to 480 HV0.2 (48 HRC) in the core material beyond 3 mm deep. The longest running of the used raceways at 30,000 h exhibited higher hardness values in the first 1 mm beneath the contact surface; peaking at 900 HV0.2 (67 HRC). Indentations made at greater depths than 1 mm tend to the same hardness gradient as the other samples, following the carburised profile of the virgin material. The intermediate service bearing raceway at 120 h displays similar hardness gradients to the 0 h raceway material.

Figure 6: Vickers micro-hardness data for M50NiL aircraft gas turbine engine bearing raceways of varying service lives. A general hardness gradient is present in all cases due to carburisation and a hardness increase is apparent in the first 1 mm of the 30,000 h raceway.

A gradient in hardness is expected in the case due to the nature of the carburisation process [11]. All three raceways have similar hardness for depths >1 mm, but the increase observed in the 30,000 h race surface is indicative of work hardening under the influence of rolling contact stresses. Arakere and Subhash [51] identified work hardening in M50NiL test rods under accelerated RCF testing, attributing this to accumulated plastic strain before shakedown. Their testing was performed at much higher contact stress levels of 5.5 GPa for 10^7 fatigue cycles, compared to the present work where the contact stress remains below 2 GPa but the number of fatigue cycles accrued over 30,000 h may exceed 10^{10} . The absence of any obvious hardness increase in the 120 h raceway indicates that work hardening develops slowly with accumulated strain during prolonged rolling contact, rather than in the initial shakedown
